Manhole Inspection Summary

Manhole # S31CC2016MH

Location Address: **5517 CHURCHWARDENS RD** Cross Street: **NORTHERN PKWY**

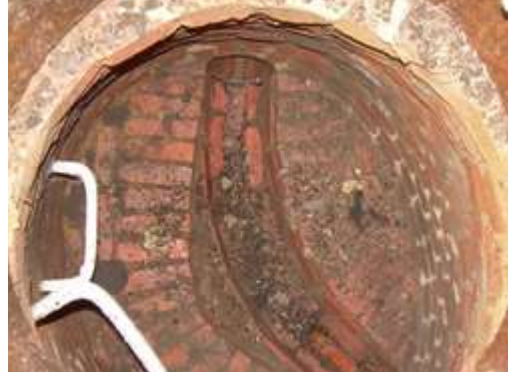
Top View

Frame offset. Adjustment deterioration and infiltration. Bench and Channel debris.

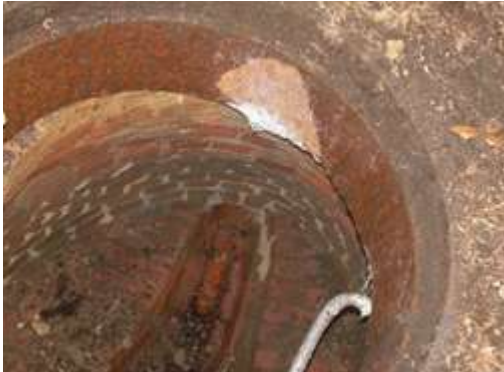
Defect

Adjustment, Corbel and Barrel infiltration.

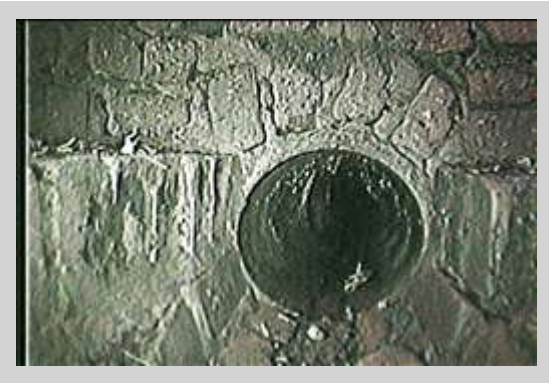
8 in. Circular Gravity Sewer Pipe Out @ 12 O'Clock

Barrel deterioration and infiltration. Channel deterioration.

Infiltration: **Evidence** Pipe Seal Cond: **Cracked**

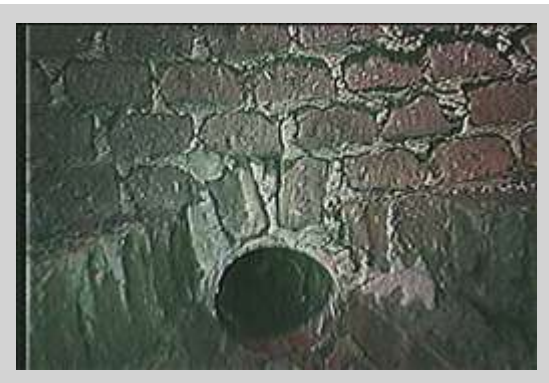
6 in. Circular Gravity Sewer Pipe In @ 5 O'Clock

Barrel deterioration and infiltration. Channel deterioration.

Infiltration: **Evidence** Pipe Seal Cond: **Cracked**
